# Structural Testing of Geopolymer Pipe & Culvert Mortar Lining System

<b>David Keaffaber, P.E.</b>	Midwest Region Manager Milliken Infrastructure Solutions, LLC
<b>Joseph Royer, PhD</b>	Development Manager Milliken Infrastructure Solutions, LLC
<b>Dan Koo, P.E., PhD</b>	Assistant Professor IUPUI Construction Engineering & Management Tech.

Purdue Road School - March 2015

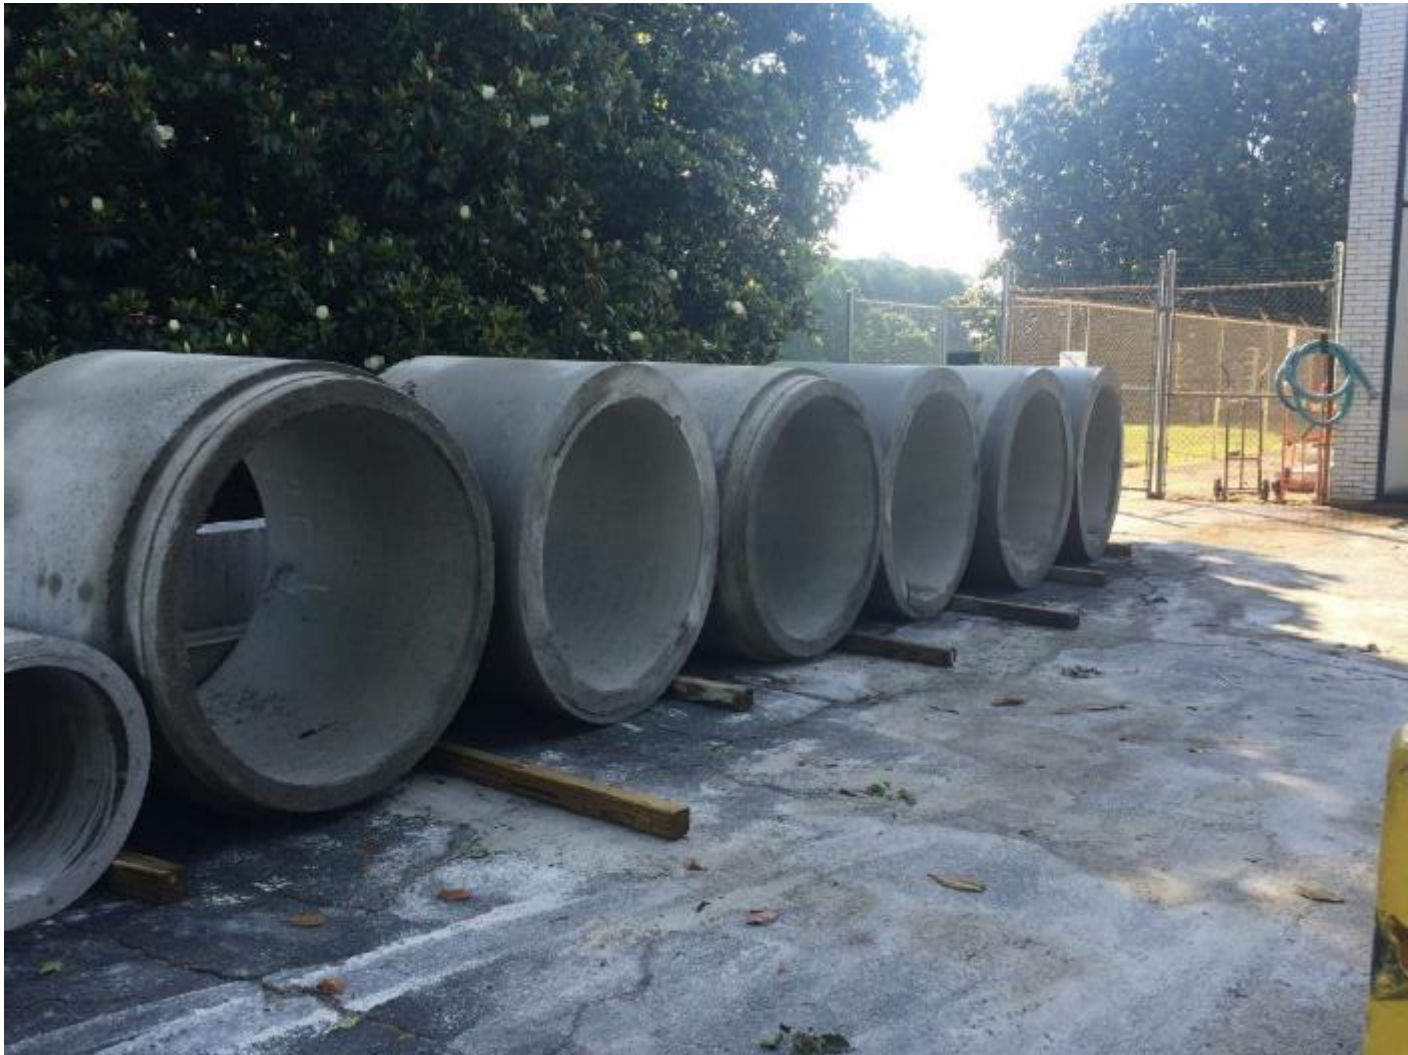
## Pipe Preparation

Preparation: All RCP Pipes were D-Loaded prior to repair with liner.

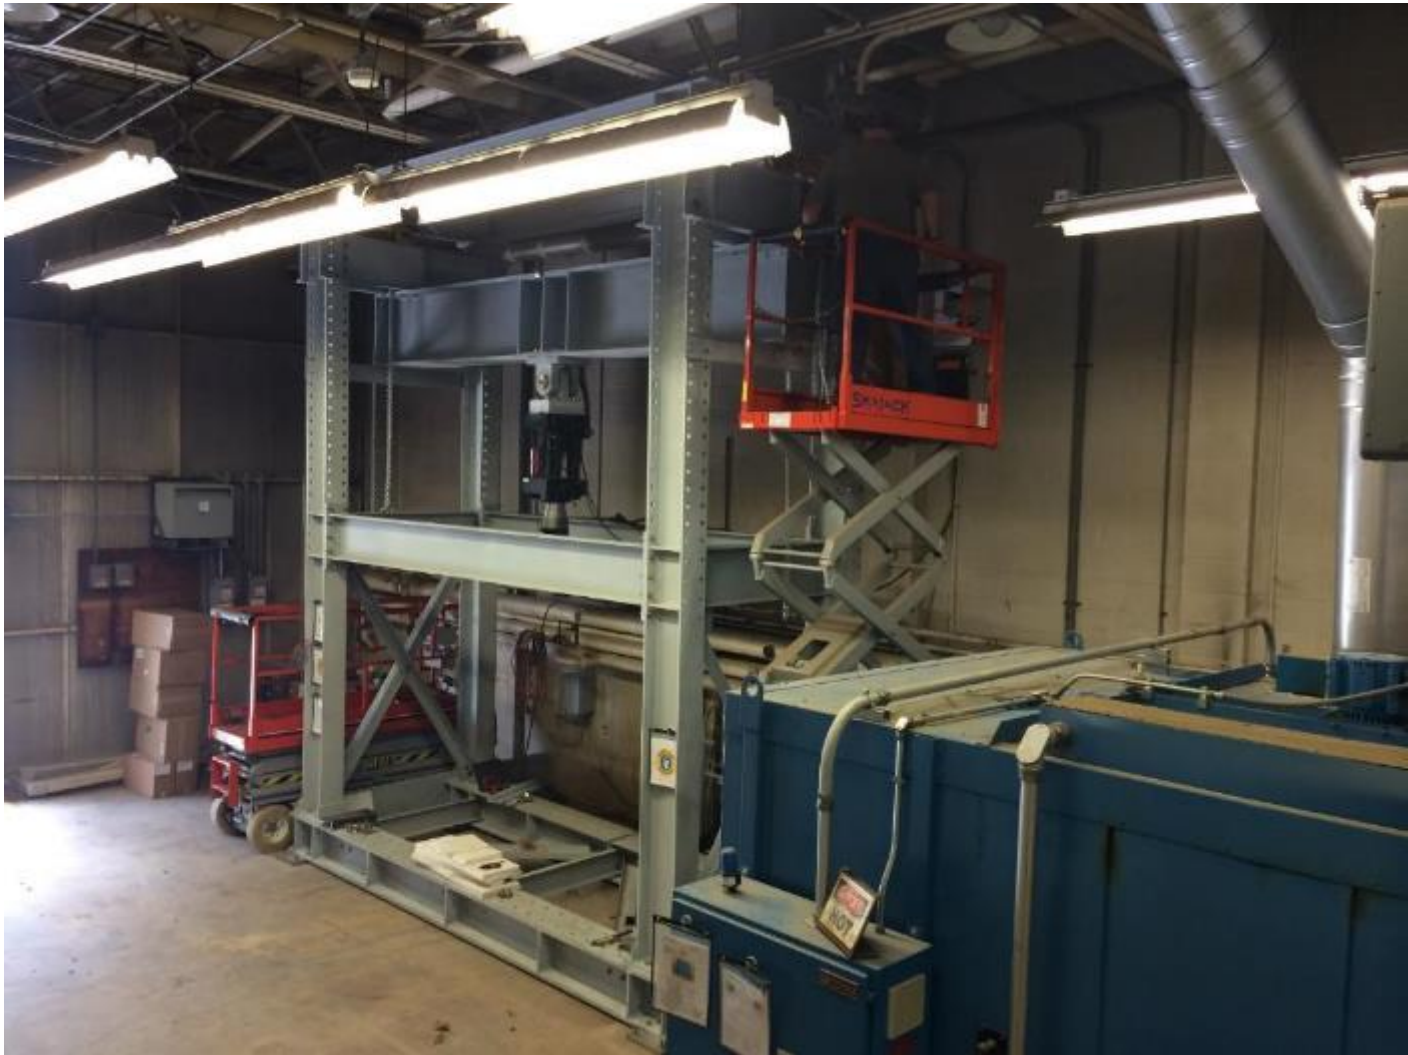
## Load Frame

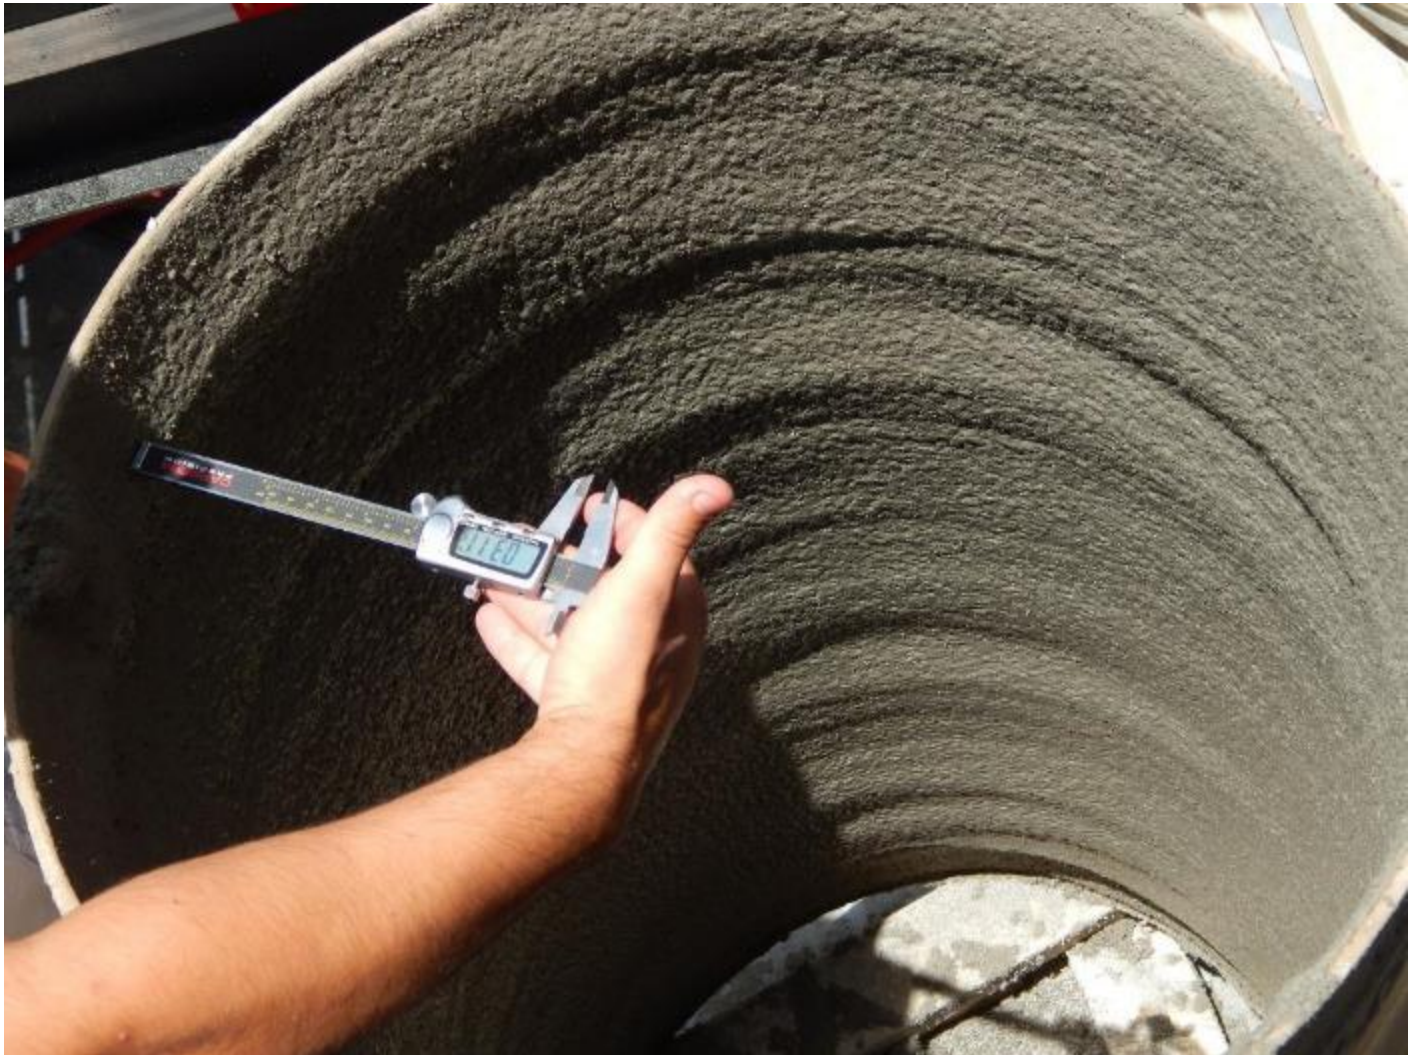
## Testing While Applying Lining

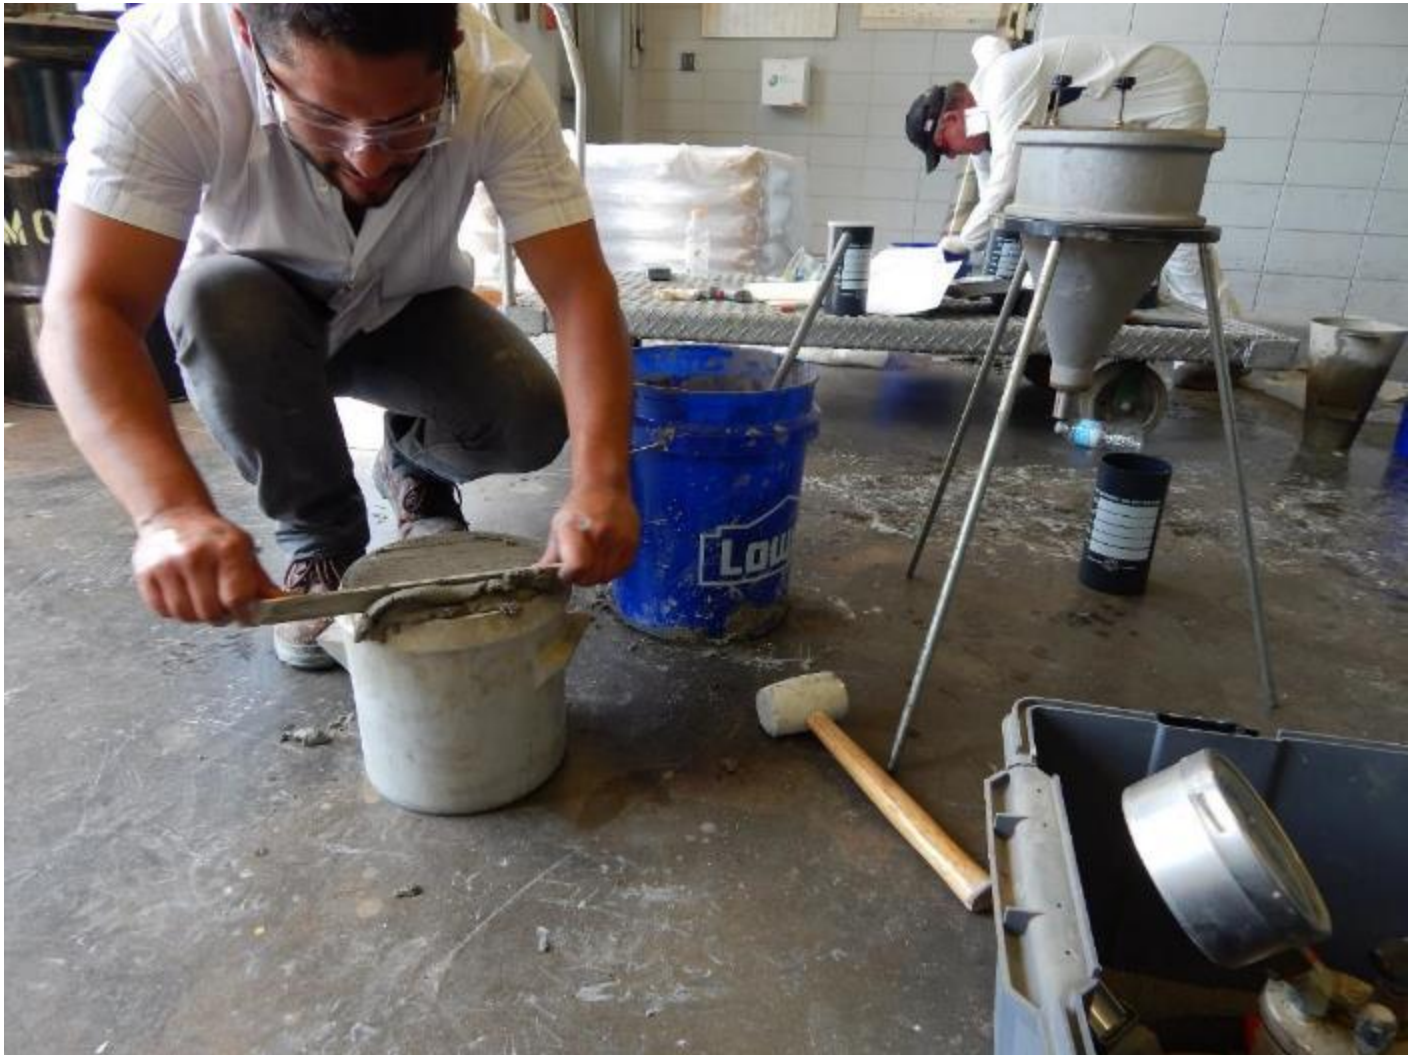
QC on Materials Conducted by 3<sup>rd</sup> Party

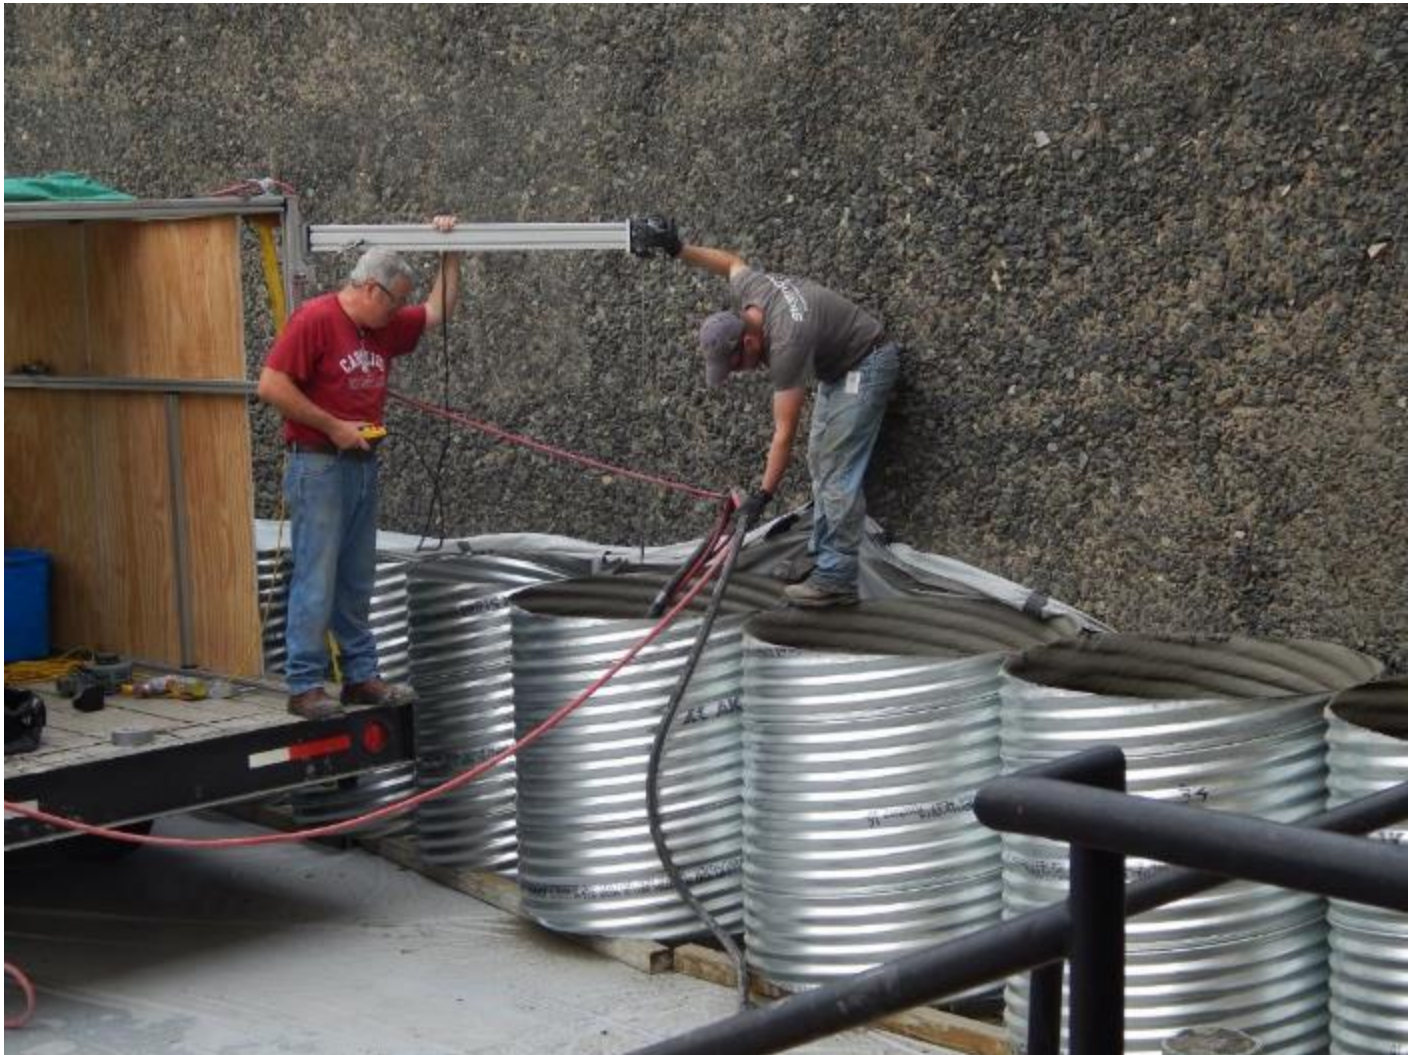
## Spraying of CMP (Vertical)

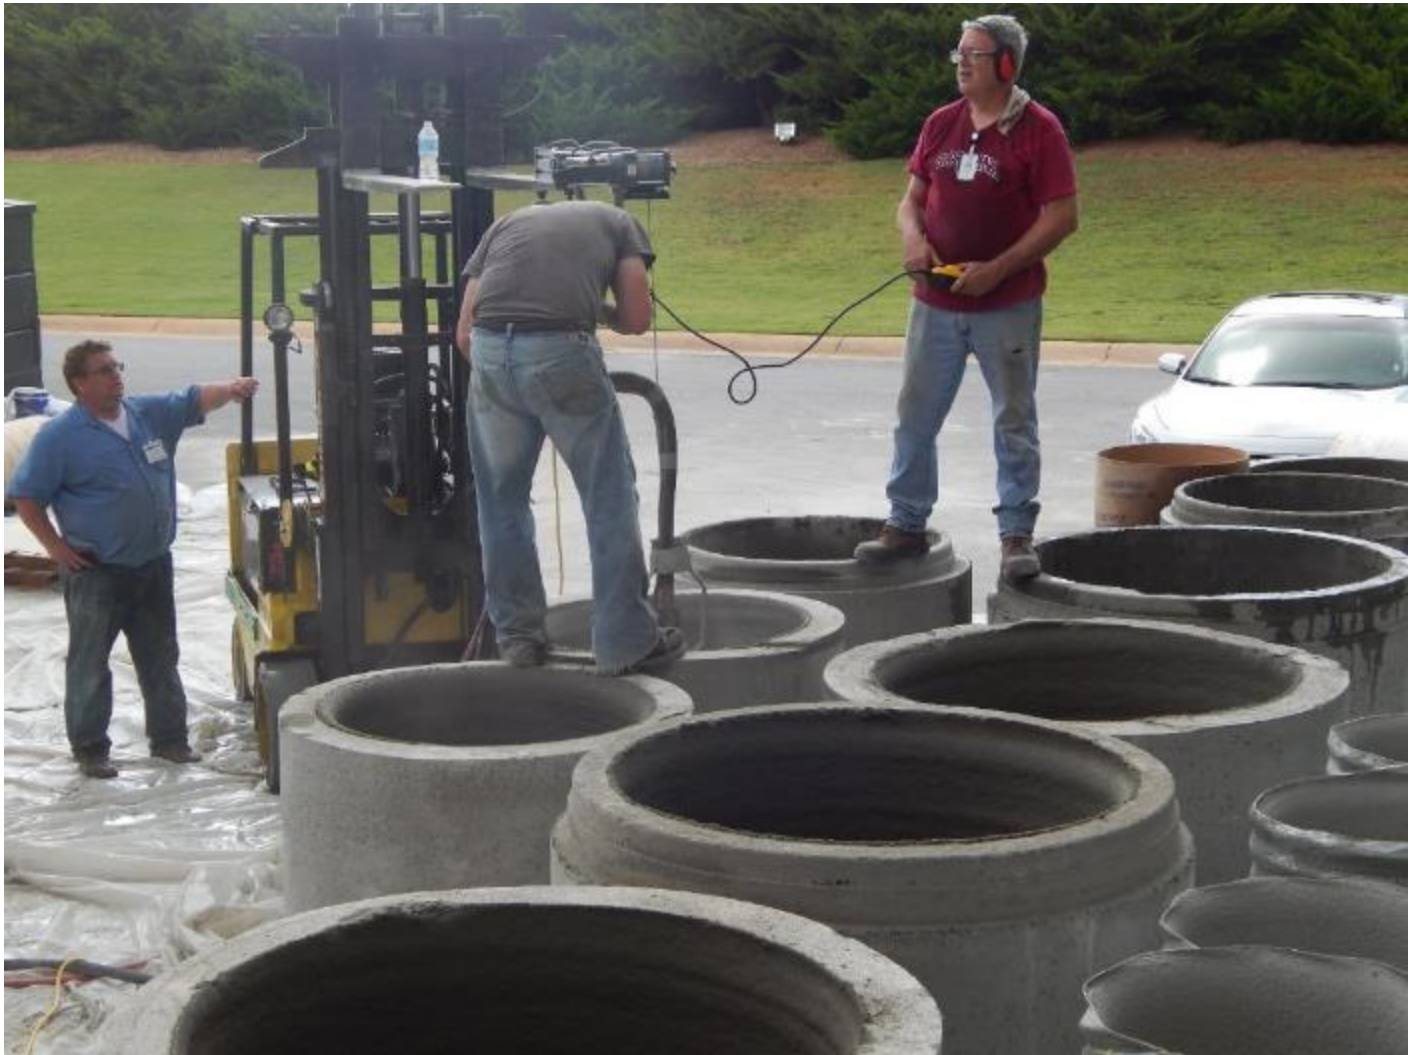
## Spraying RCP - Vertical

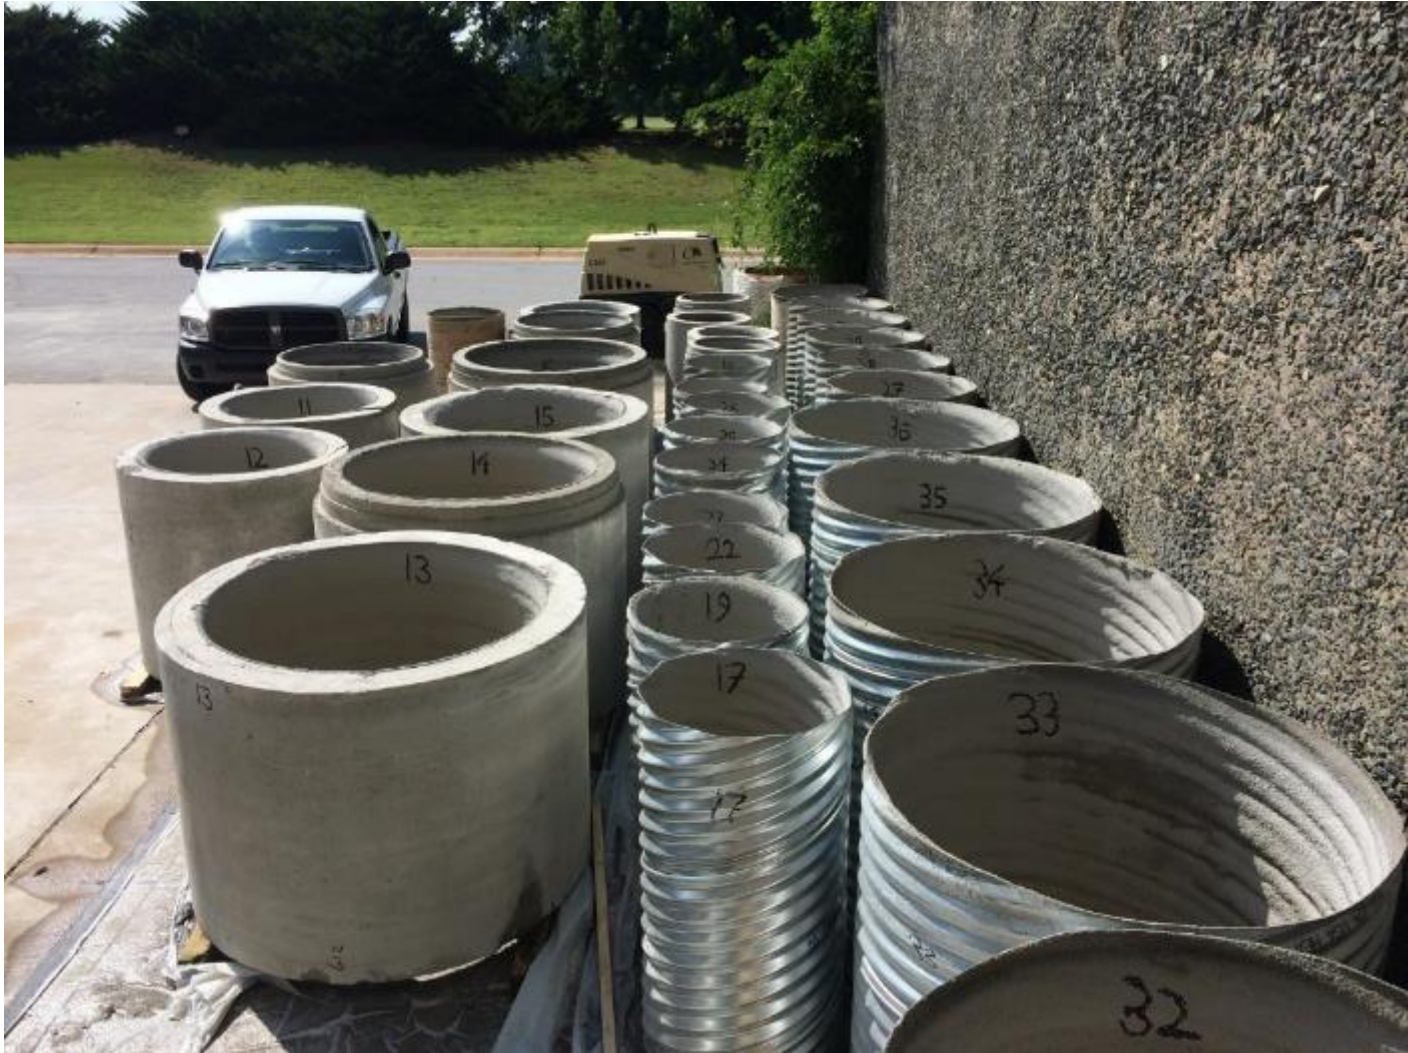
## Complete Test Samples

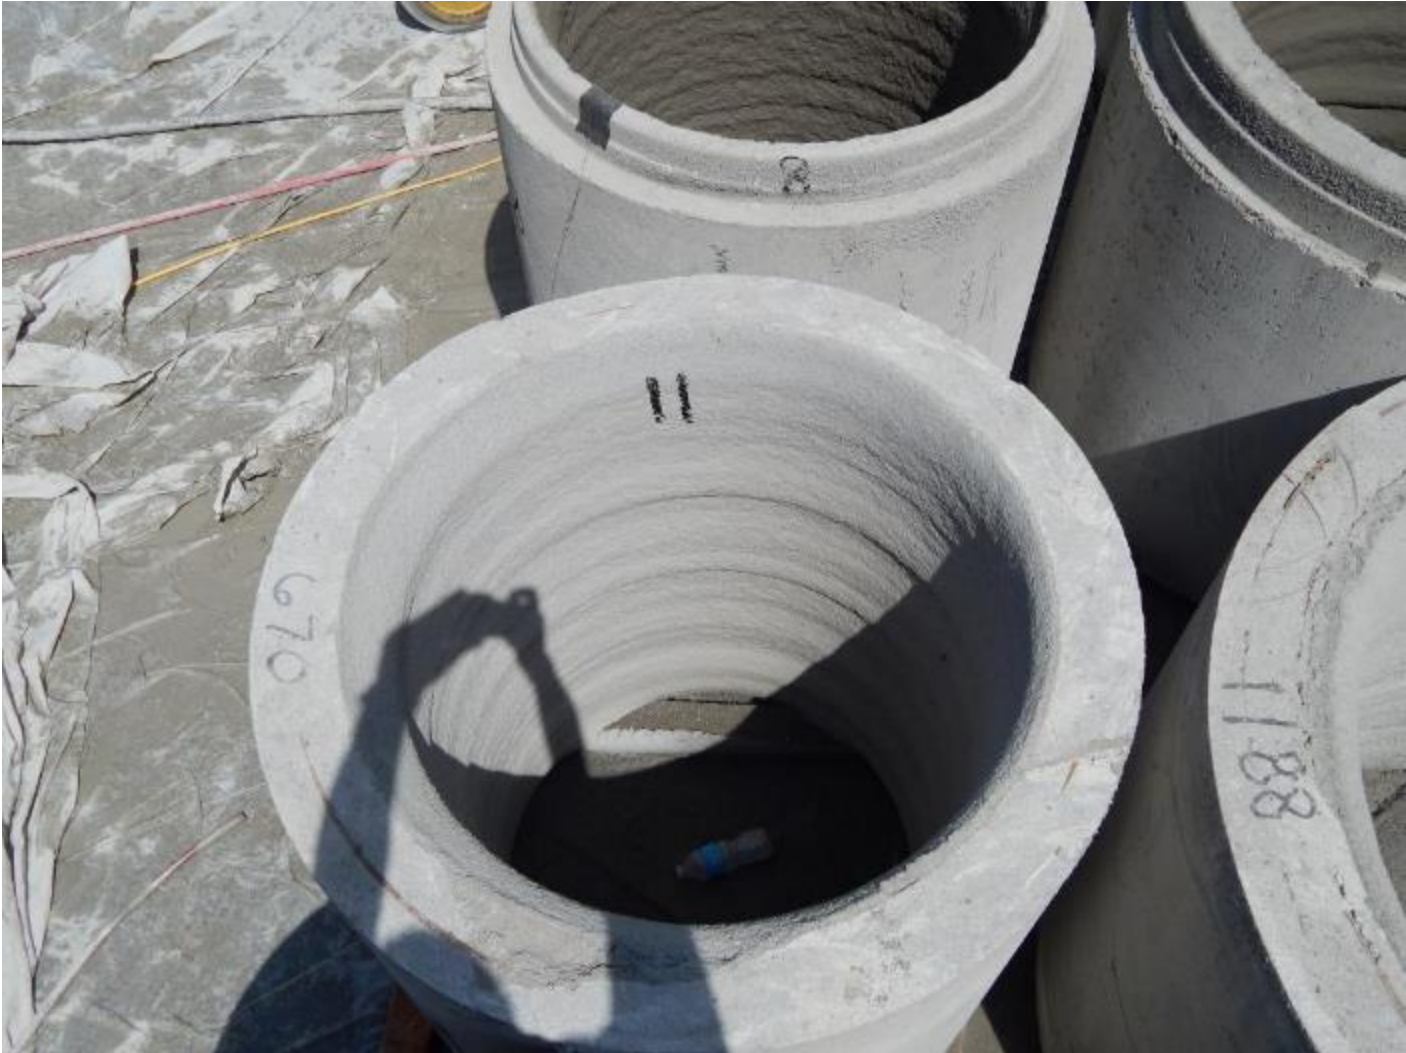
## Close Up of Sprayed RCP

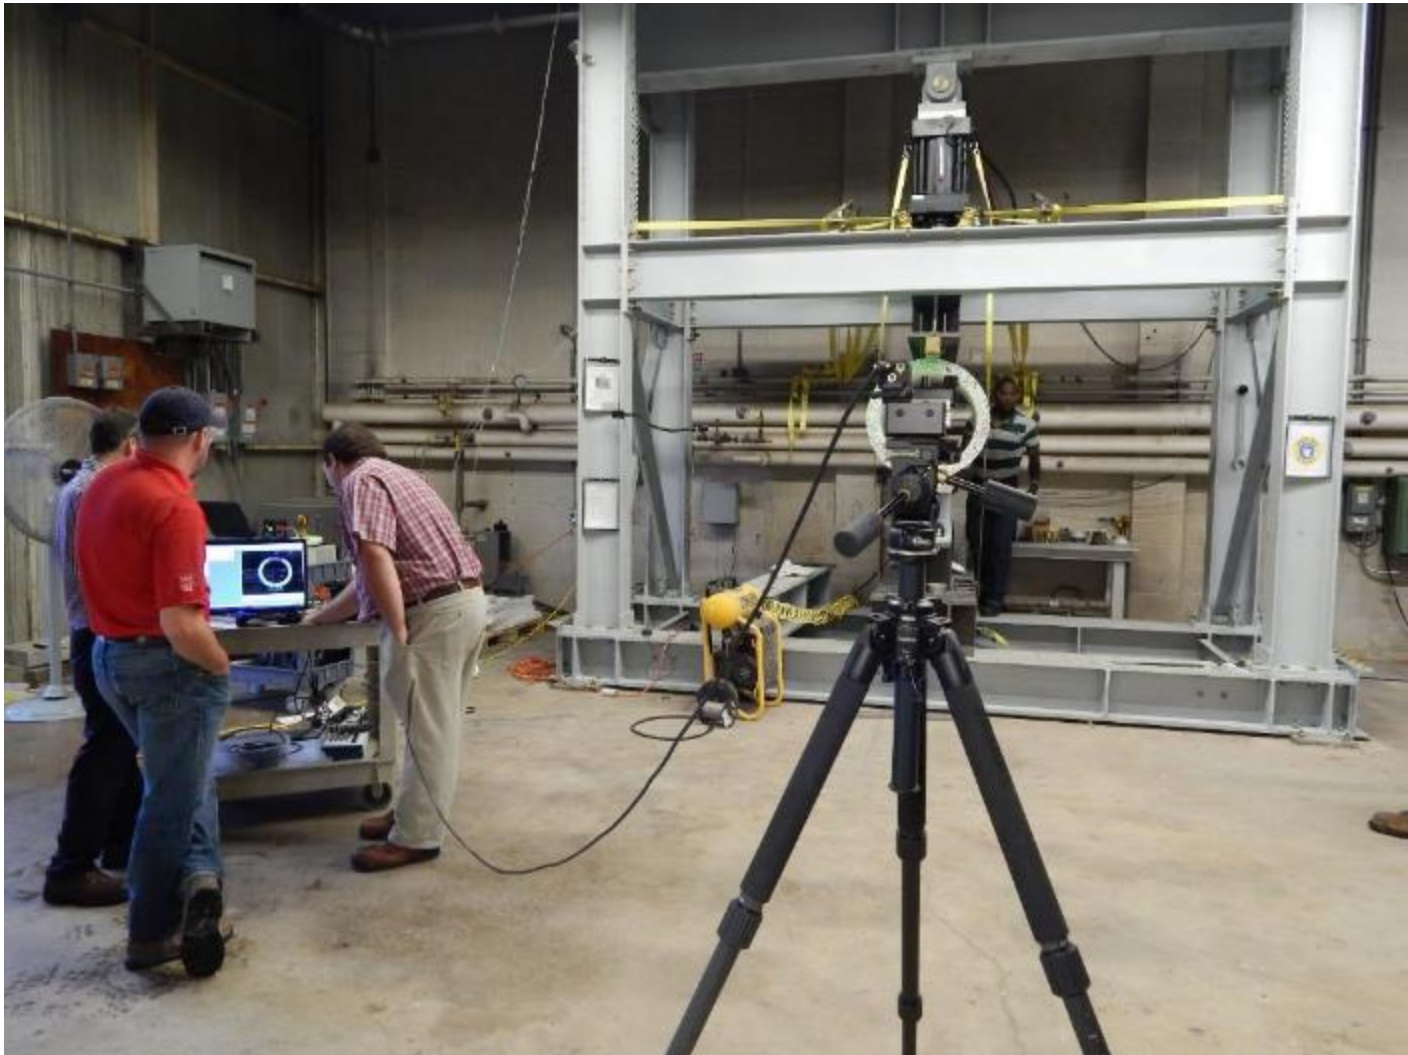
## Load Frame Ready to Go

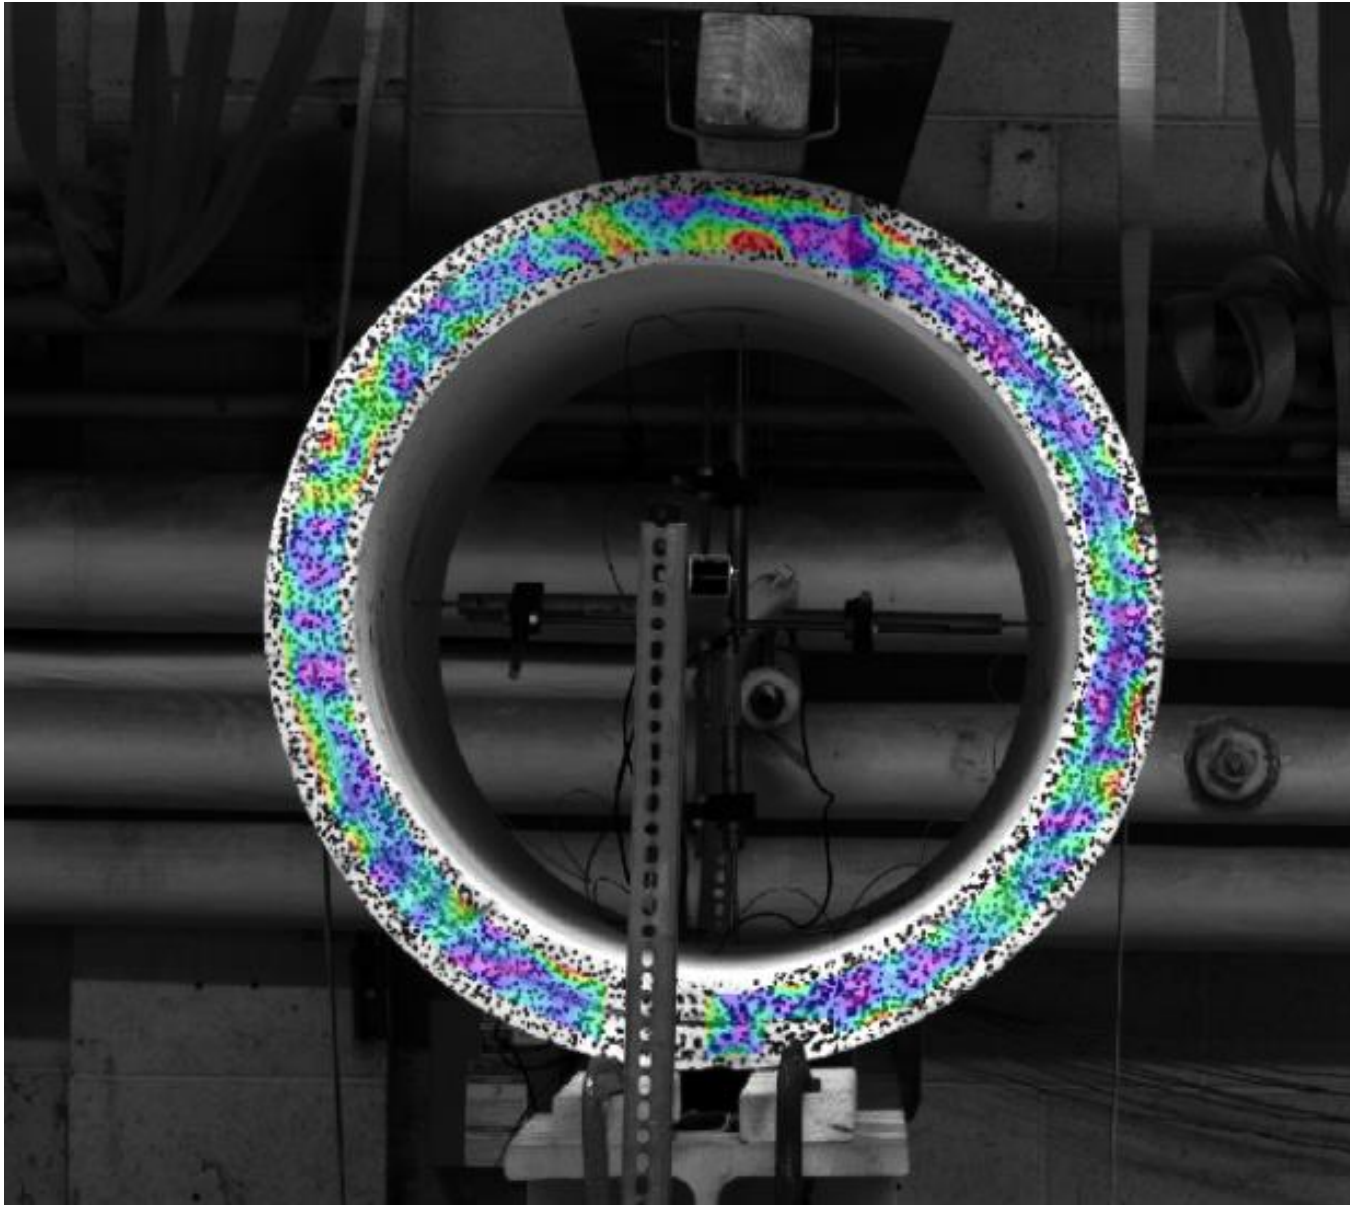
## UnCoated RCP

24" RCP	Control 1	Control 2	0.66 " Liner	0.66" Liner	1.33" Liner	1.33" Liner
Load @ Break	17,400	11,800	12,500	10,800	21,700	15,100
% of						
<p>Within experimental error, which all of the RCP pipe that were repaired (independent of liner thickness) were as strong as the original pipe and above the ASTM acceptance standards for new pipe.</p>						
Load @ Break	17,900	20,700	16,100	18,600	28,500	36,000
% of Control	N/A	N/A	-17%	-4%	48%	81%

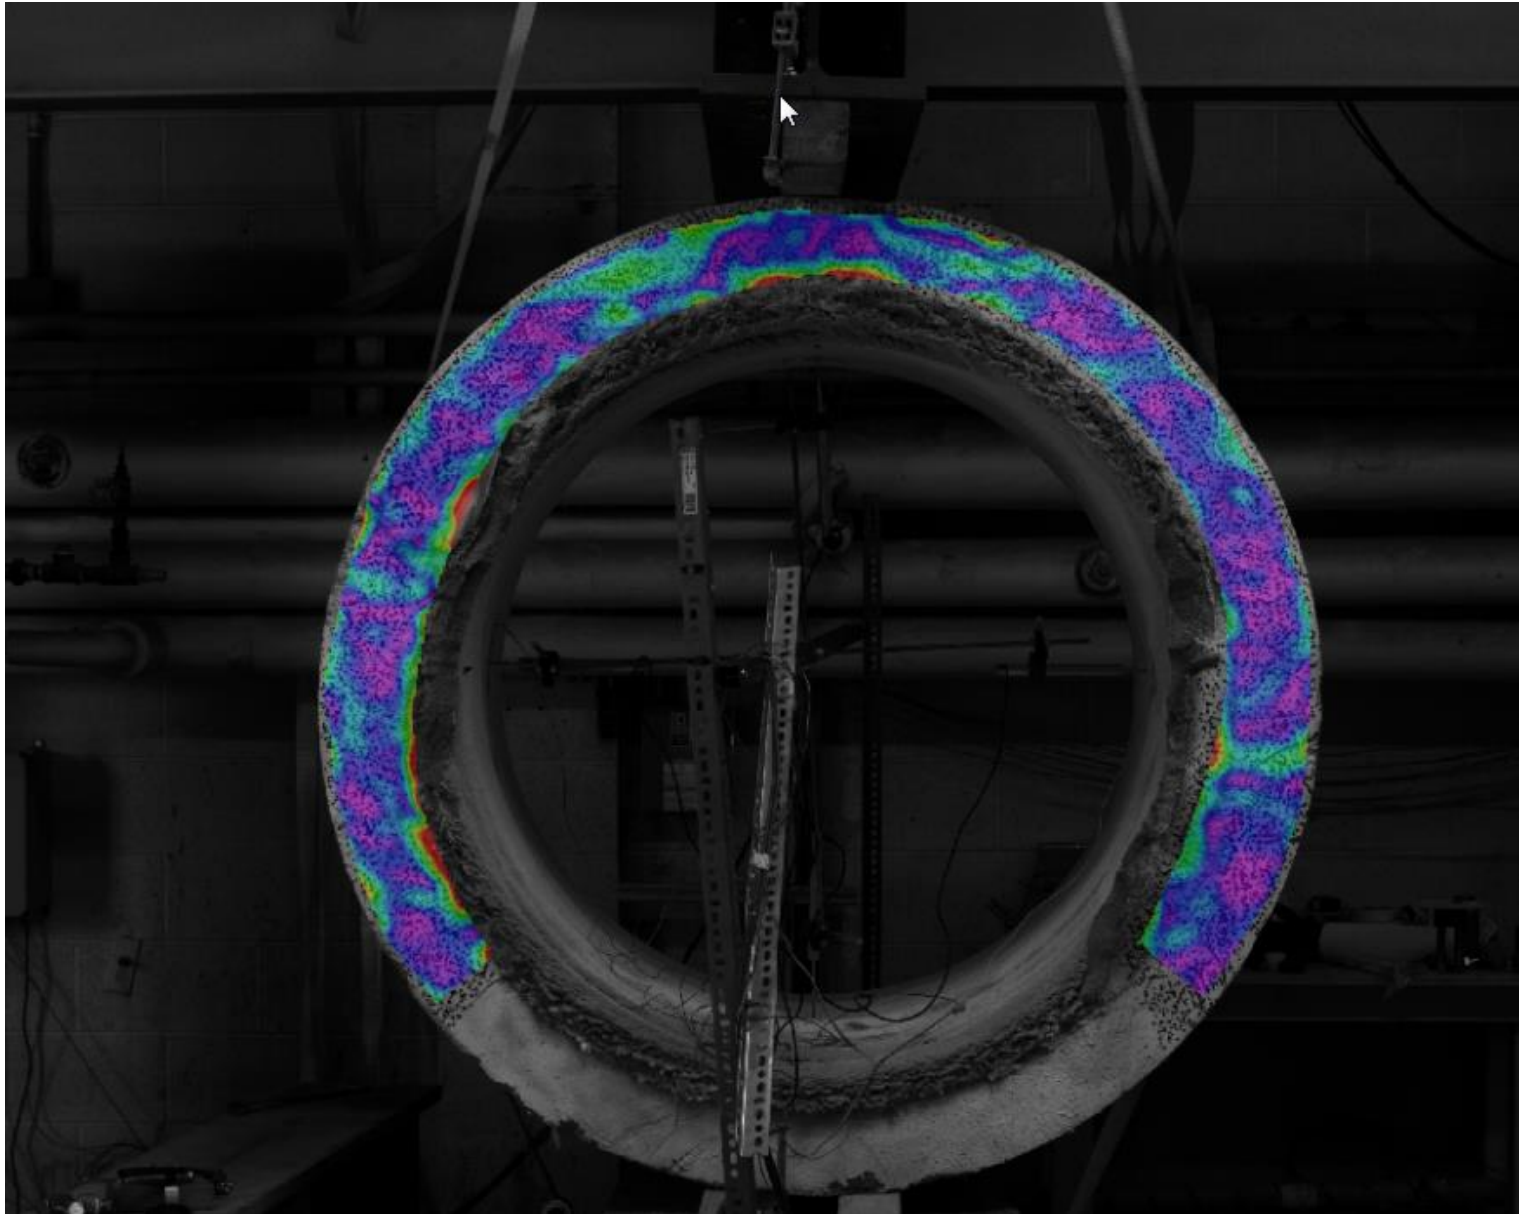
## Coated RCP Pipe

RCP Pipes tested as good as new pipes with as little as 0.66 inch coating, suggestion that if the reinforcing steel is still good only material thickness of original is needed. If cracking is heavy a thicker lining can be used to restore original strength.

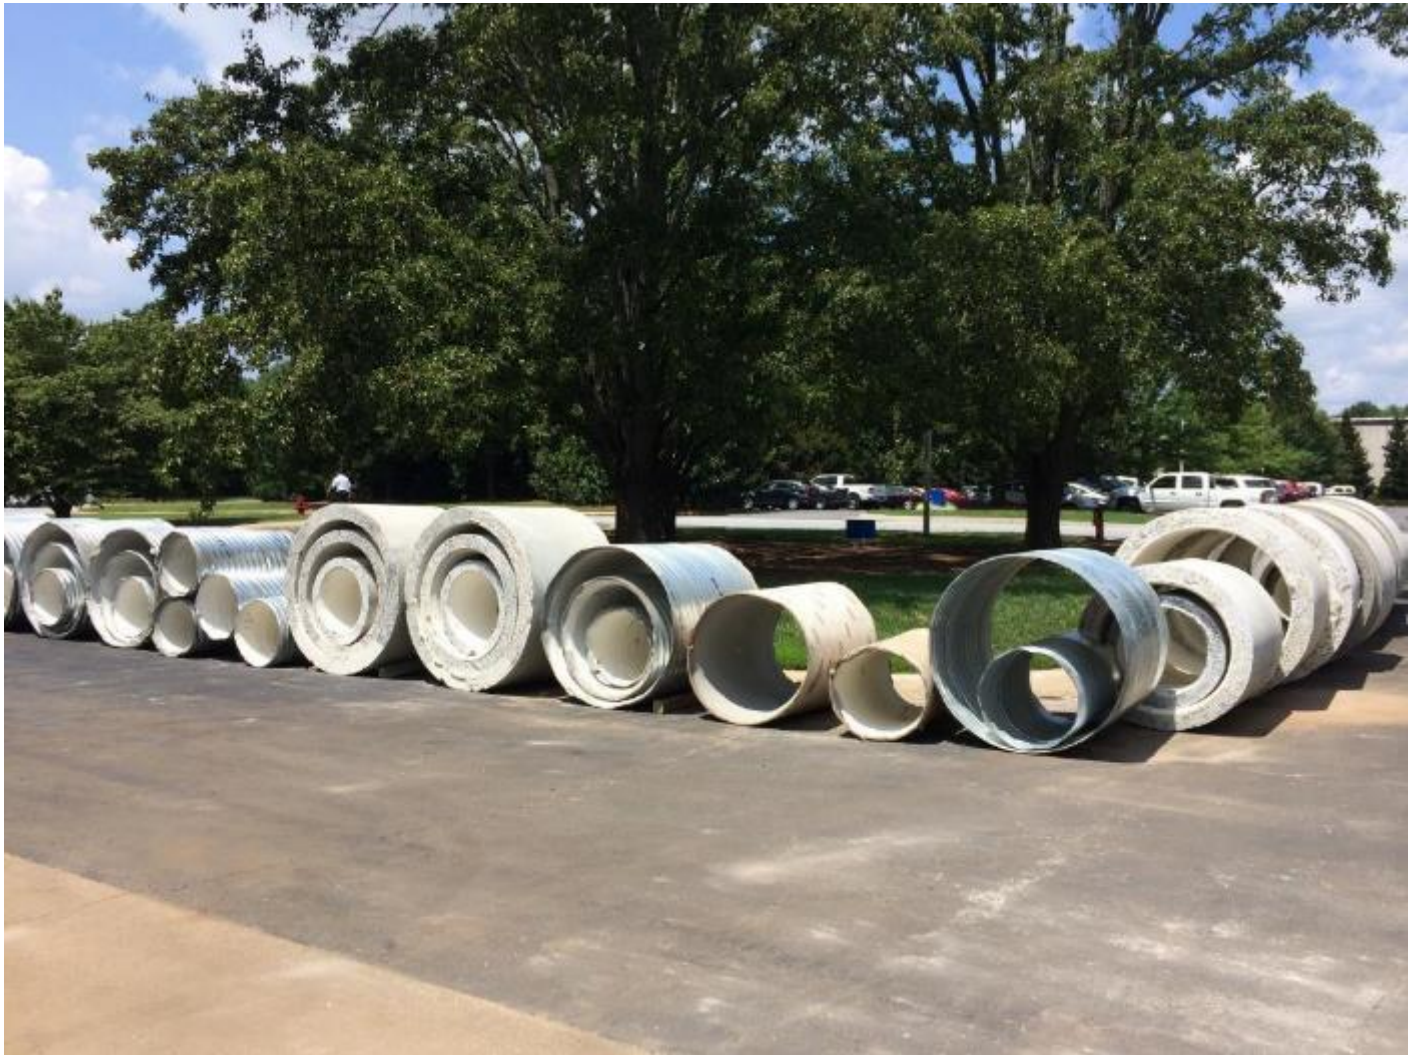
## Completed Testing Pipes

RCP, CMP and Cardboard Tubes were Tested after 28 days curing.
